OFFICE OF EXPERIMENT STATIONS—BULLETIN 249, PART II.

THE STORAGE OF WATER FOR IRRIGATION PURPOSES—PART II.

TIMBER DAMS
AND
ROCK-FILL DAMS.

SAMUEL FORTIER,
Chief of Irrigation Investigations,

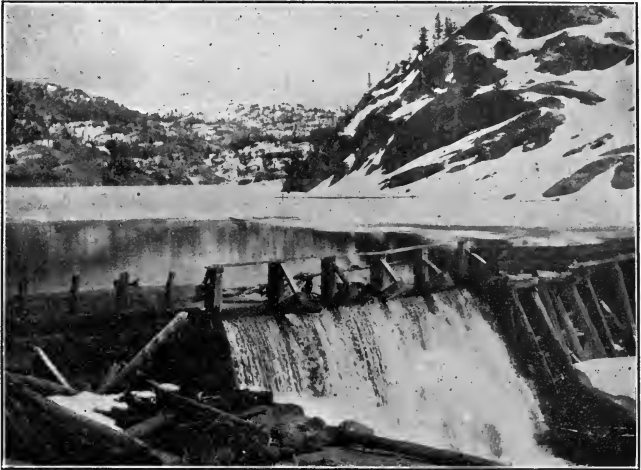
The surplus water from the reservoir flows over a spillway constructed at one end of the dam. This spillway (fig. 4) is 35 feet wide and 3 feet below the crest of the dam. It is equipped with flashboards, so that the water level of the reservoir may be varied at least 2 feet. The posts supporting the flashboards are 6 by 6 inches and spaced 7 feet centers. At times when the river is low the water is drawn from the reservoir by means of a "slum" gate, which is opened and closed by a threaded screw, at the top of which is a capstan nut operated by an iron bar. The gate slides on the upstream slope of the dam. The dam is in a bad state of repair, it being difficult to renew any part, owing to the decayed condition of the wood.

FIG. 4.—Spillway, Big Dam, South Fork Stanislaus River, Cal.

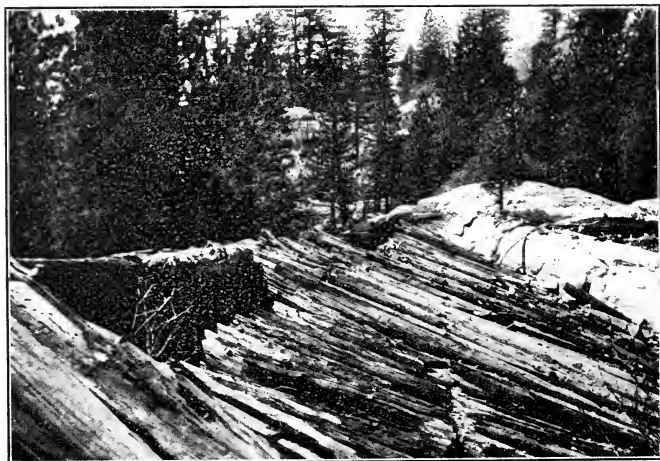
FIG. 6.—Abandoned portion of Middle Dam, illustrating the placing of logs on upstream slope of continuous-crib dams.

in the cribs and the notching of one on another has been shown in figure 6. The timber used in the construction of this dam was taken

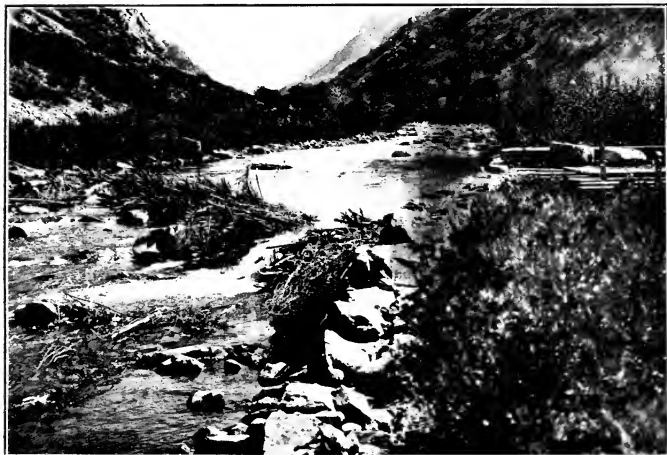
FIG. 1.—BRUSH DAM, WEBER RIVER, UTAH.

From the use of a small mat, weighted with rock, placed in creeks and small streams, the practice grew to include the damming up of some fairly large rivers for diversion purposes. A brush dam of the old type is shown in Plate I, figure 1. For 20 years or more this cheap weir and its predecessors, that were carried by floods into Great Salt Lake, served to divert water from Weber River, Utah, into the Davis and Weber Counties Canal.

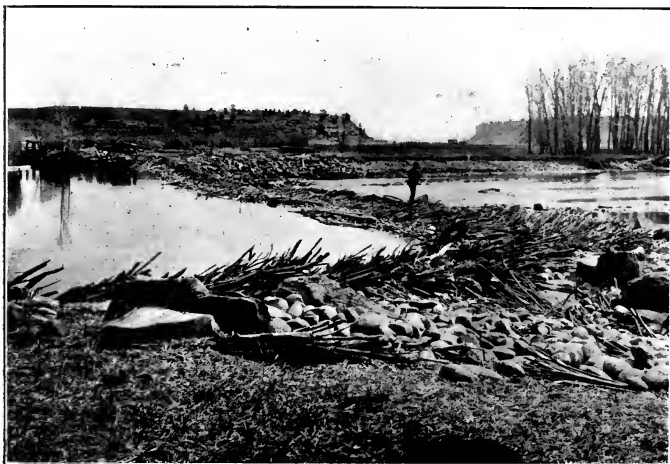
FIG. 2.—A BRUSH DAM ON THE YELLOWSTONE RIVER.

In the larger dams of this kind the brush is tied into bundles with galvanized-iron wire, these bundles being deposited in layers with the butts downstream and weighted with rock and bowlders. A good example of this construction is shown in Plate I, figure 2. This dam has served for a score or more of years to divert water from the Yellowstone River into the Big Ditch, which irrigates about 25,000 acres of land near Billings, Mont. Figure 1 is a view of the same dam when it was undergoing repairs.

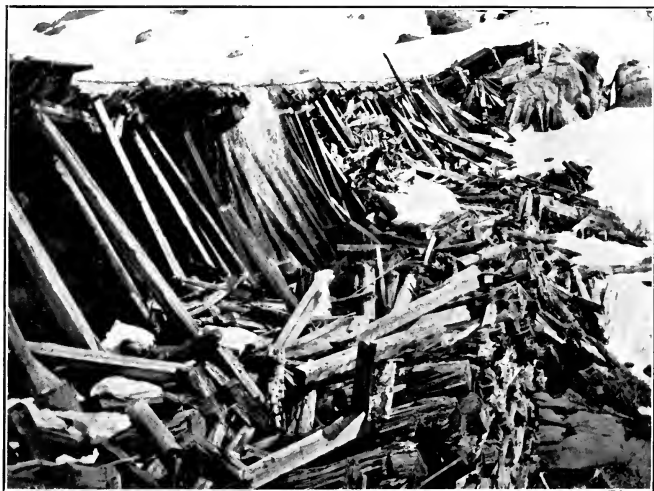
FIG. 2.—SAME, SHOWING DÉBRIS GATHERED AT FOOT OF DAM.

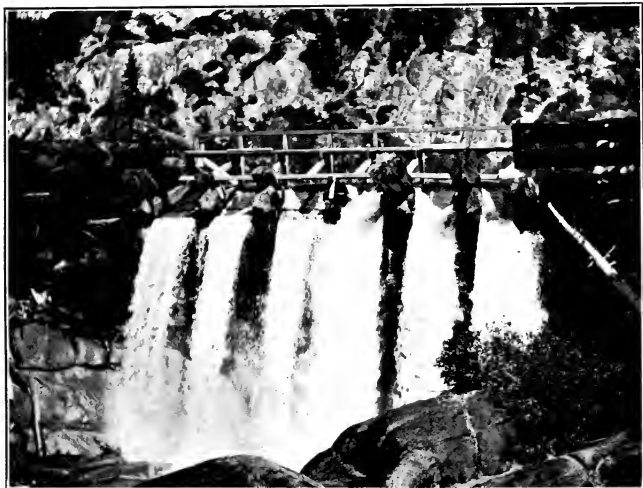
FIG. 1.—WASTEWAY, MIDDLE DAM, SOUTH FORK STANISLAUS RIVER, CAL.

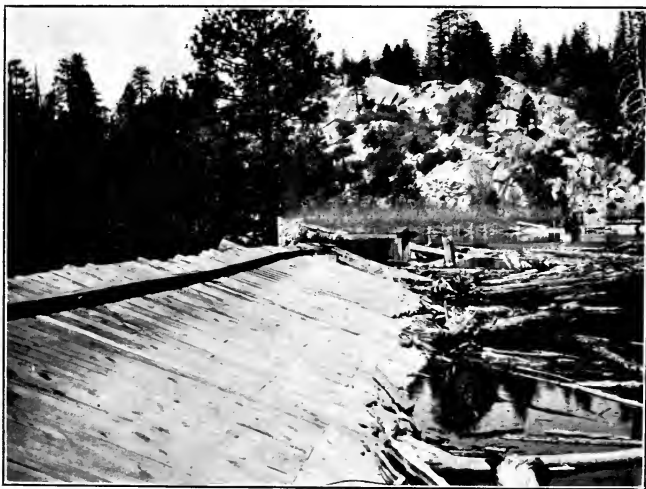
FIG. 2.—PLANKING ON UPSTREAM FACE OF MIDDLE DAM, SOUTH FORK STANISLAUS RIVER, CAL.

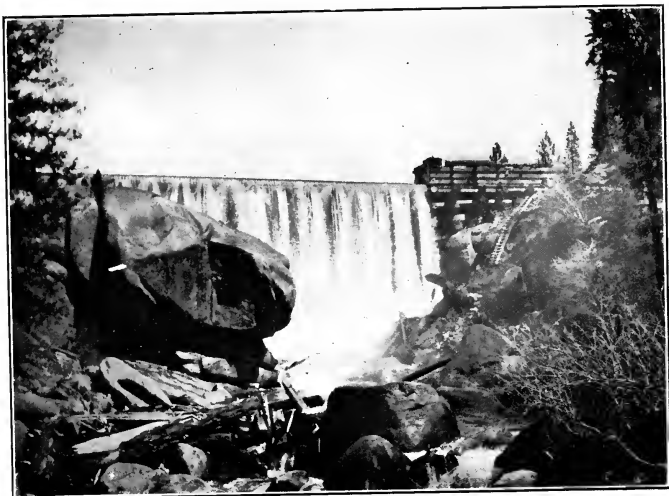
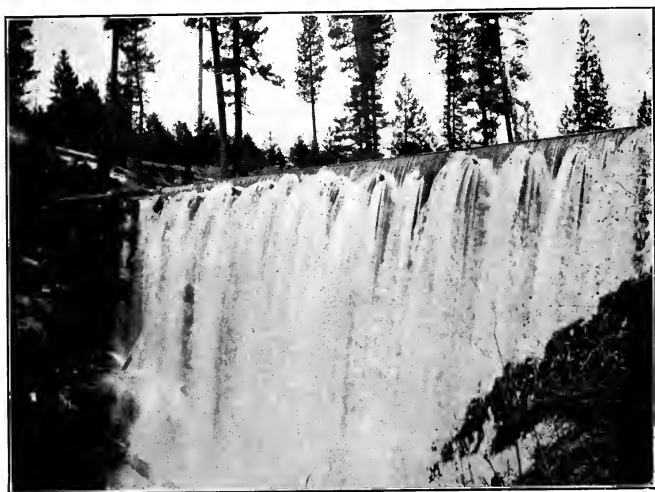
FIG. 1.—LYONS DAM, SOUTH FORK STANISLAUS RIVER, CAL.

FIG. 2.—LYONS DAM, ANOTHER VIEW.

This dam (Pl. IV, figs. 1 and 2) is the fourth of the series and completes the chain of reservoirs belonging to the Tuolumne Water Co. It was constructed in 1896-97, after plans and specifications prepared by the consulting engineer. The contract called for \$17,000, but with extras the actual cost of building was \$21,000. A plan and elevation of this dam are shown in figure 9.

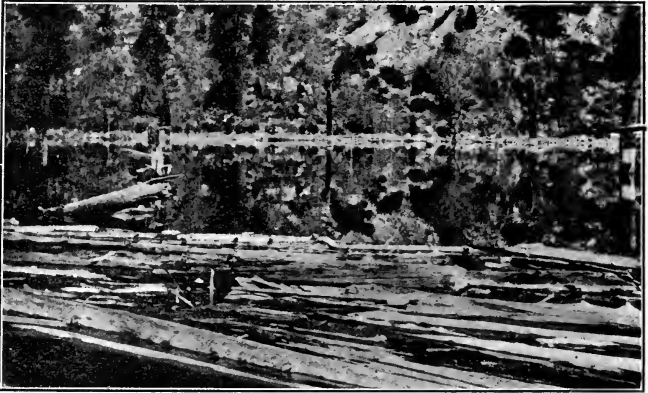
FIG. 7.—Débris gathered at Middle Dam, Tuolumne Water Co., Cal.

improper connections between the logs the boom broke. Figure 7 shows the result.

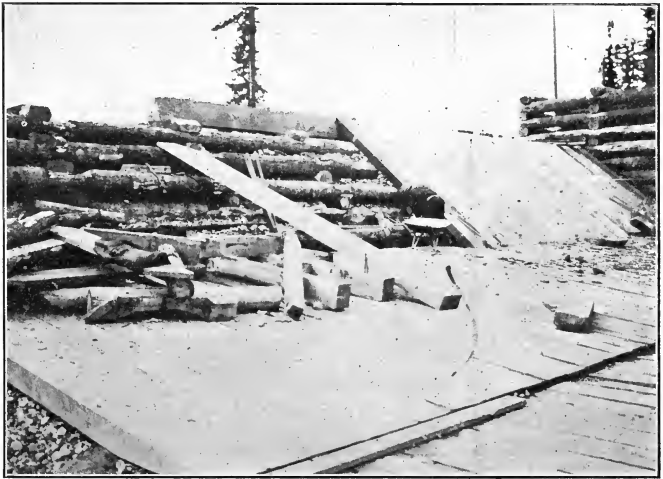
FIG. 12.—Lake Keechelus Dam, apron and spillway under construction, crest log in place and apron completed on east end.

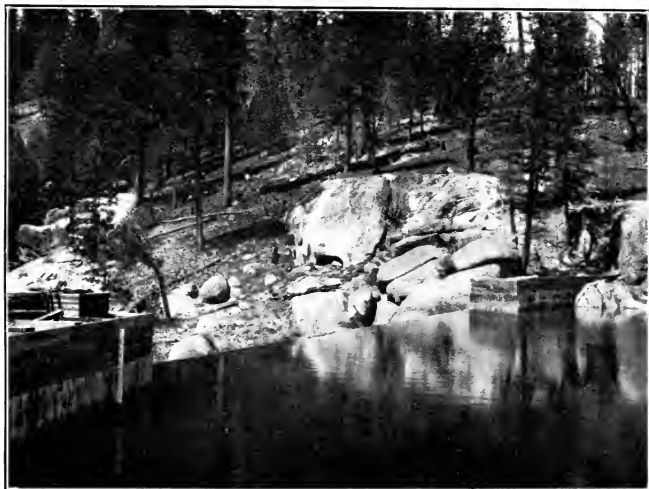
FIG. 1.—BULKHEADS AND CREST OF SPILLWAY, FROM UPSTREAM SIDE, LYONS DAM, CAL.

heavy grade of roofing paper to increase the imperviousness. At both ends of the dam bulkheads consisting of cribbing were built up about 7 feet above the crest of the dam and well anchored to the bedrock. These bulkheads were then faced with planking and filled with loose rock, adding to the stability. (Pl. V, fig. 1.)

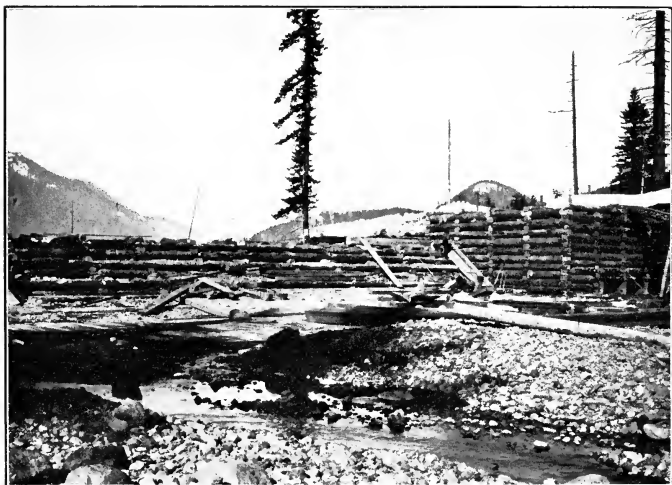
FIG. 1.—LAKE KEECHELUS CRIB DAM DURING CONSTRUCTION, DOWNSTREAM VIEW.

and a clay and gravel embankment with a slope of 2 to 1 was placed on the upstream side of the cribbing. The surface of this embankment was then paved with hand-placed riprap. The cribbing on the downstream side (Pl. VI, fig. 1) was constructed so that the logs were on a $1\frac{1}{2}$ to 1 slope for the upper 12 feet (horizontal measurement), and then a slope of 6 to 1 for the next 12 feet. The latter slope breaks onto the apron, which is 24 feet wide. The apron and spillway were covered with 6-inch hewed timbers with $1\frac{1}{2}$ -inch open joints and secured to the logs at every intersection with two $\frac{5}{8}$ by 13 inch drift bolts. (Fig. 12.) All holes for drift bolts were bored $\frac{1}{8}$ inch smaller than the diameter of the bolt. To bring the channel up flush with the apron a rock fill with a slope of 15 to 1 was placed at the toe of the apron and consisted of hand-placed riprap.

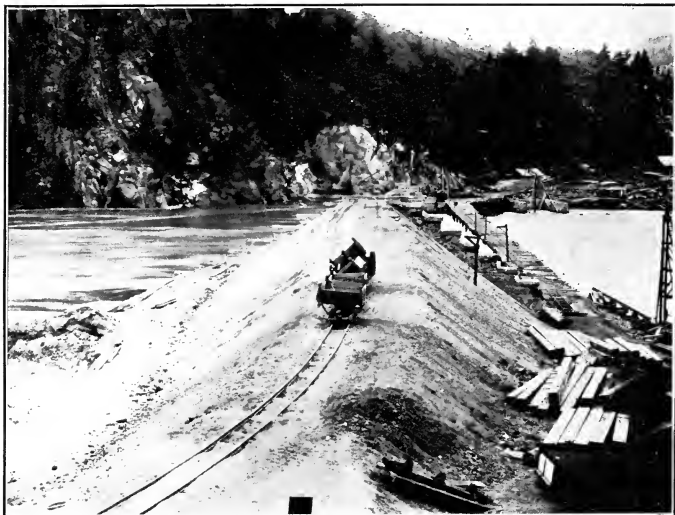
FIG. 1.—METHOD OF CONSTRUCTING EARTH FILL AT END OF CRIB DAM, CANYON FERRY DAM, MONT.

height of $12\frac{1}{2}$ feet above its crest or flow line. On the east bank an earthen dam 285 feet long with a masonry core wall and slopes of 2 to 1 and $1\frac{1}{2}$ to 1, respectively, on the upstream and downstream sides, was built to the hillsides. (Pl. VII, fig. 1.) The top of the dam is at the level of the top of the abutments.

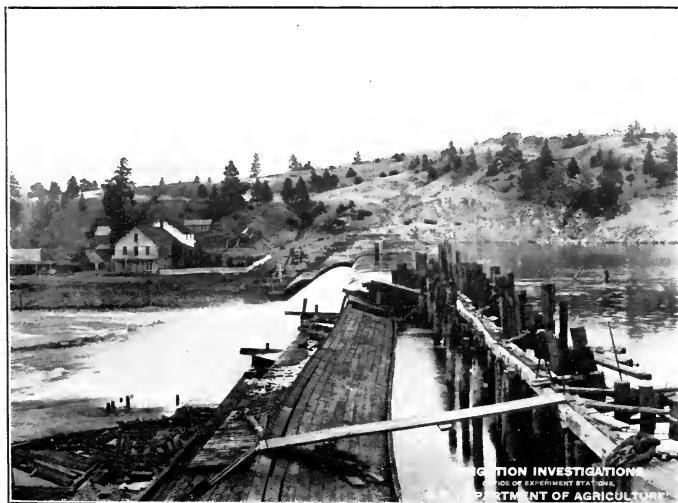
FIG. 2.—CANYON FERRY DAM, BEFORE RECONSTRUCTION.

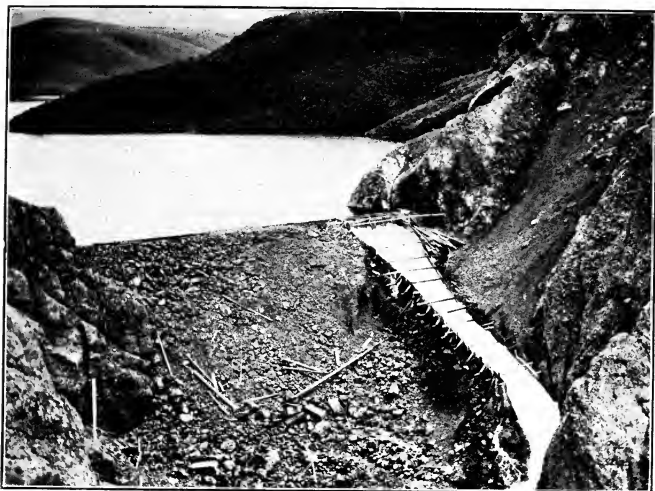
FIG. 1.—EAST CANYON DAM, UTAH, SHOWING TEMPORARY SPILLWAY.

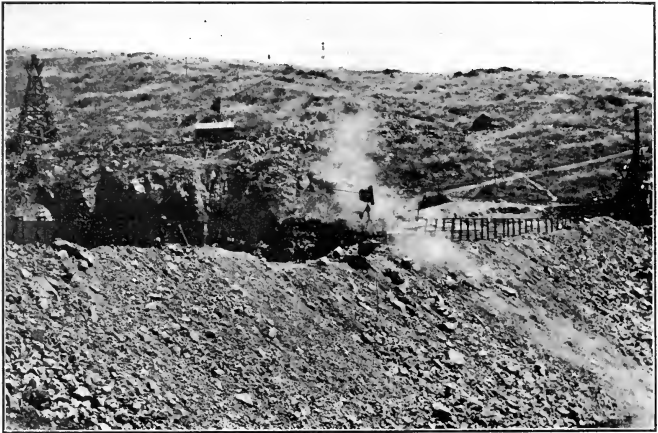
FIG. 25.—Lower Otay Dam—two cableways delivering rock from quarry.

The rock was brought from the quarry by means of a Lidgerwood cableway, having a span of 950 feet and capable of handling a safe load of 10 tons. The cable on which the carriage traveled rested on two towers, one 130 feet high and the other 60 feet. This difference in height was due to the difference in elevation where the two towers stood. The cable crossed the dam at an angle of about 60°, the main cable being 60 feet above the crest of the dam. The rock was delivered on the dam by this cableway (fig. 25), and until the dam reached a height of 75 feet it was distributed wherever needed by derricks. The length of the dam at this point being so great that it could not be handled without transferring from one derrick to another, another cableway was erected to take the place

of the derricks. This also was a Lidgerwood cableway, but the towers were built on heavily ballasted cars on wheels which could be moved on tracks from a point 15 feet below the core to a point the same distance above, the cable between these towers being parallel to the axis of the dam. This cable was only 30 feet above the dam, thus allowing sufficient room for loads to be carried above it by cableway No. 1. In the quarry a derrick was placed so that a load could be picked up in any part of the quarry and set down directly under the cable.

A loaded skip would be handled in the following manner: First, the derrick would pick up the loaded skip and set it down under cableway No. 1 and take an empty skip back to be reloaded. Cableway No. 1 would then hoist the load and carry it on the dam, where

the chains would be unhitched from this and hitched to an empty skip to be taken back to the quarry. Cableway No. 2 would then hoist the load, carry it wherever needed, spill it, and set the skip back under cableway No. 1 before the latter had returned with another load. In this way the cableways and derrick would all be at work without interfering with each other. As high as 225 loads were handled in 10 hours, and the daily average of 200 loads was made for several weeks at a time. This number could have been increased if the quarry had been above the top of the dam. In the present case the level of the bottom of the quarry was but 20 feet above the base of the dam. The time consumed in hoisting and lowering was equal to one-fifth of the time taken to handle a load from the quarry to the dam.

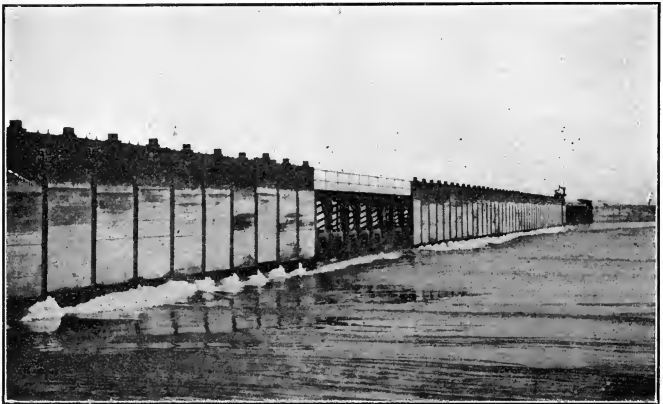
FIG. 29.—Gates in Milner Dam, Snake River, Idaho. At times of high water these gates are raised to regulate flow in canals.

Before building the north or main-channel dam it was planned to cut a tunnel through the point of the south island of sufficient size to carry the low-water flow during construction. This tunnel consisted of eight sections, each 5 feet wide and 9 feet high. The flow of water was controlled by heavy cast-steel gates, raised by geared stands. (Figs. 29, 30.) Quoting from Schuyler's work, already referred to:

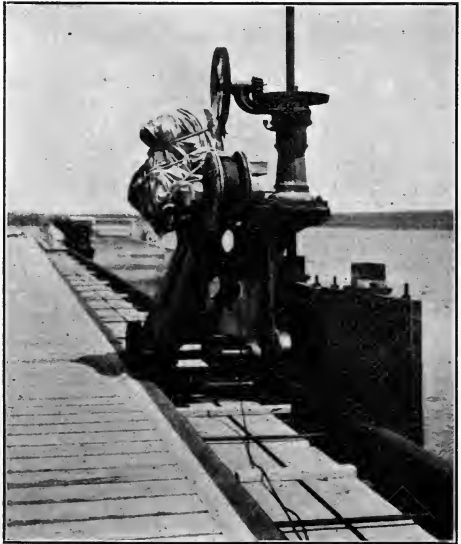
FIG. 30.—Milner Dam, showing lifting apparatus operated by electric motor.

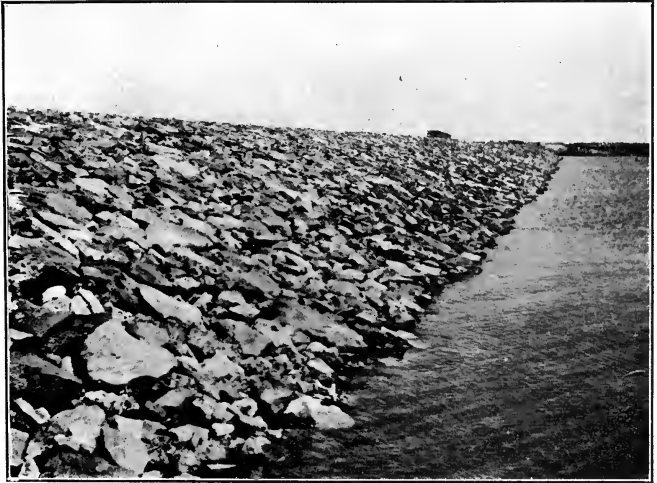
FIG. 33.—Riapped slope, Minidoka Dam, Snake River, Idaho.

The main dam is of the loose-rock-fill type, with a concrete core back filled on the upstream slope with earth and gravel. This slope has a heavy gravel face protected by cyclopean riprap (fig. 33).

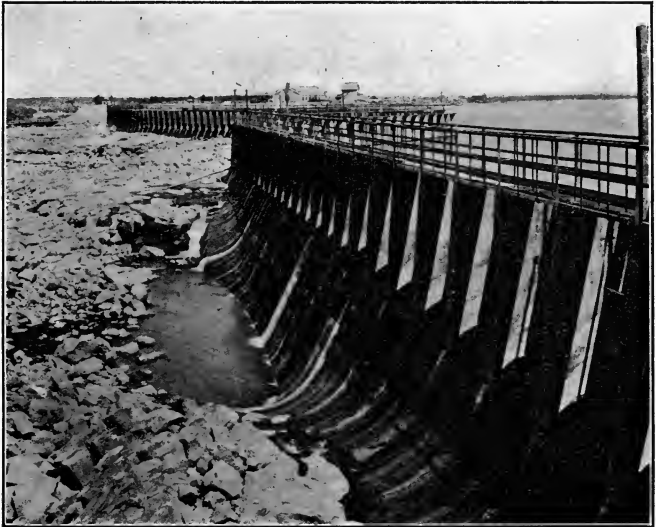
FIG. 36.—Spillway, Minidoka Dam, Idaho (U. S. Reclamation Service).

spillway (fig. 36), 2,385 feet long, was built at the south end of the dam, following the highest ridges of rock. The excavation for the
